Inspection report for the property at

1234 Fake Street

This report is prepared exclusively for **John Doe**
Inspected On: **2023-02-10**

Sighthound Home Inspections, LLC
850-296-8329

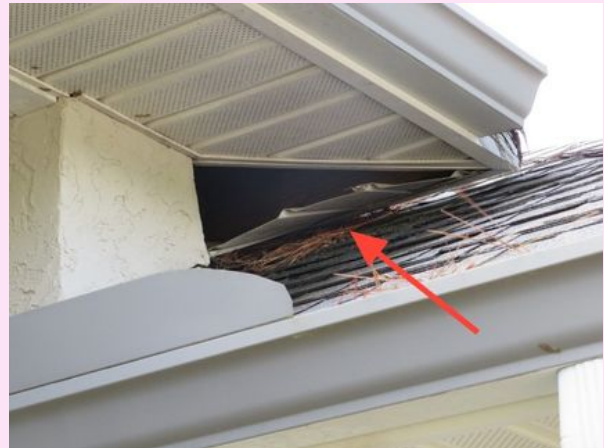
E1-4 EXTERIOR/GROUNDS: Vented soffit in the area of the front entrance is pulling from the fascia and sagging down. This is creating a large opening in the buildings envelope where moisture, animals, or other pests may enter the attic space. I recommend the soffit be repaired by a qualified and licensed contractor.

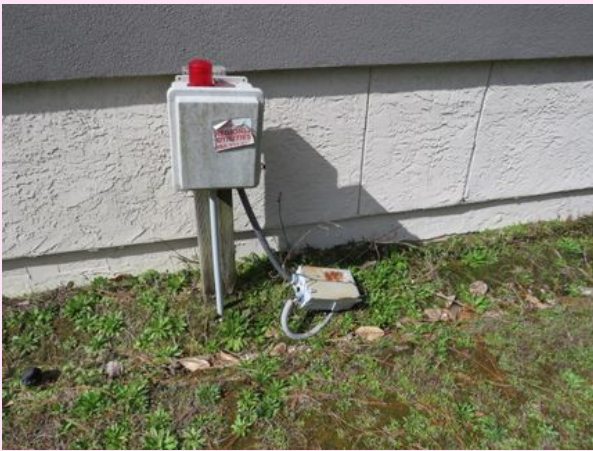
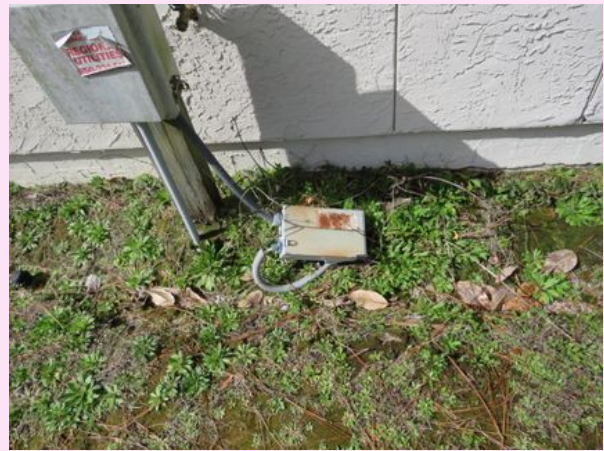
E-9 ELECTRICAL: The service disconnect for the grinder pump was observed laying on the ground. I recommended a qualified electrical contractor mount this service disconnect box appropriately and assess the box for any water damage or signs of electrical shorts.

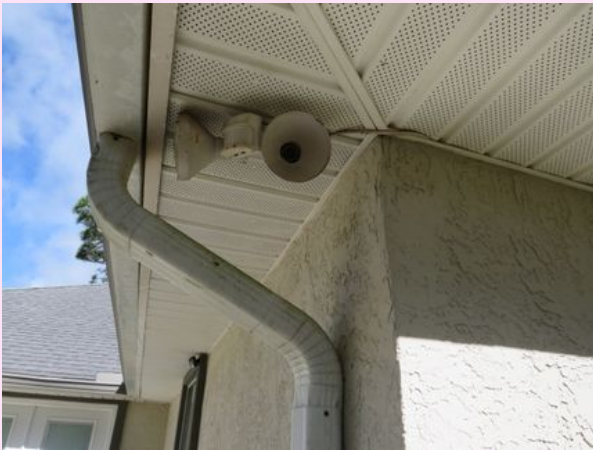
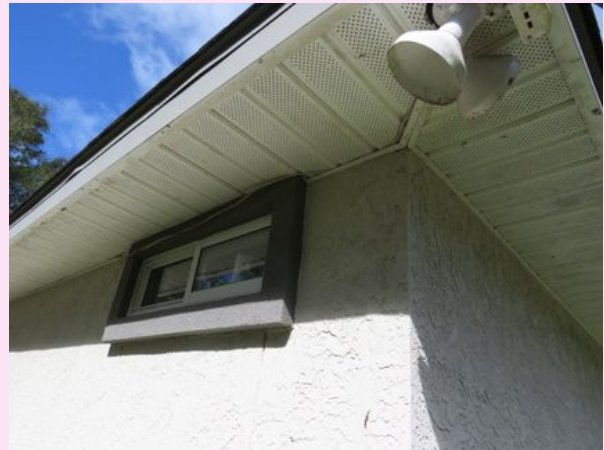
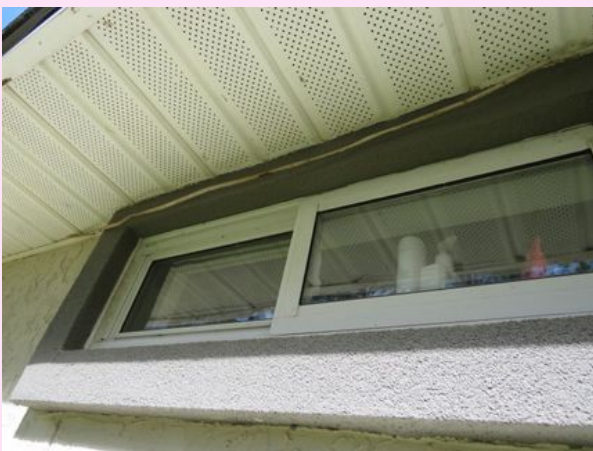
E-10 ELECTRICAL: Unprotected wiring was observed on the rear exterior floodlights. I recommend a licensed electrical contractor assess and repair.

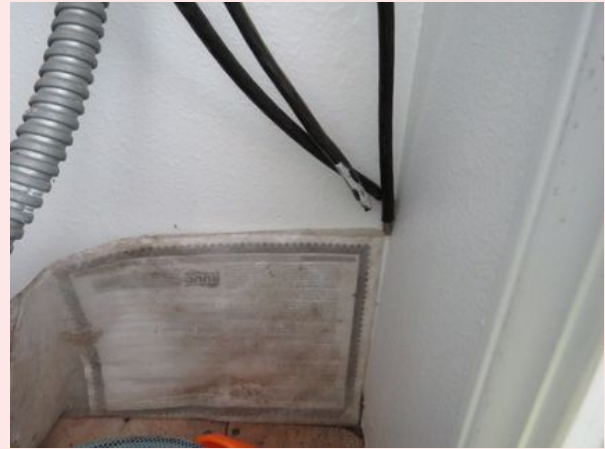
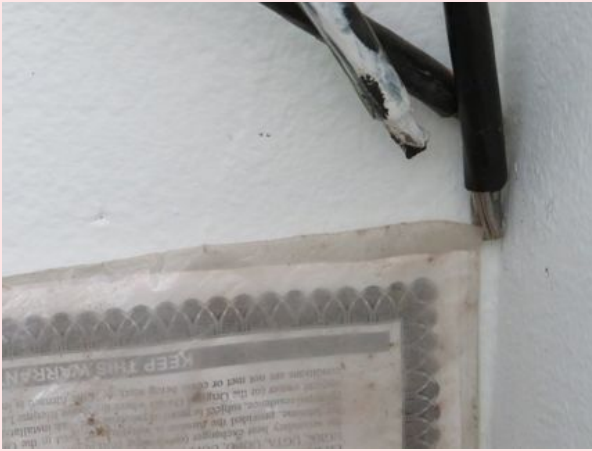
E-7 ELECTRICAL: Exposed wiring was observed coming from the attic space into the area near the garage central HVAC unit. These wires appear to be large gauge aluminum wires. While a voltage detector utilized by the inspector indicated these conductors are not "hot", they are not appropriately capped and terminated. I recommend a qualified electrical contractor assess and repair appropriately, as this could be a safety concern to the house and its occupants.

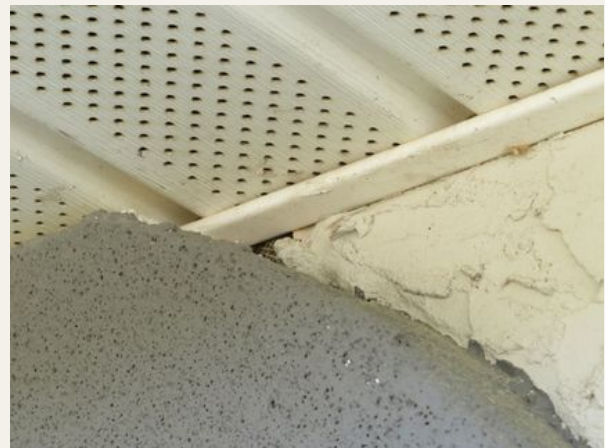
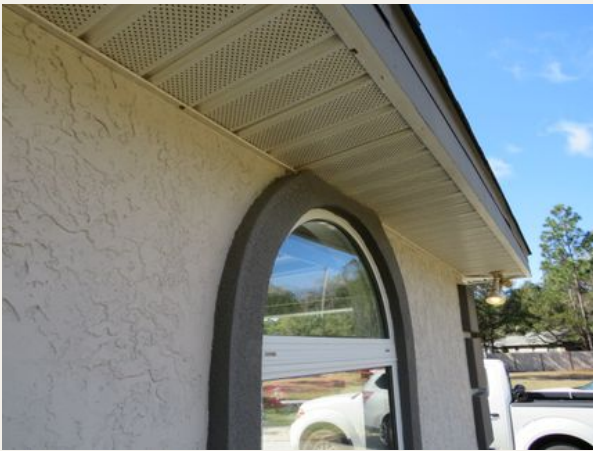
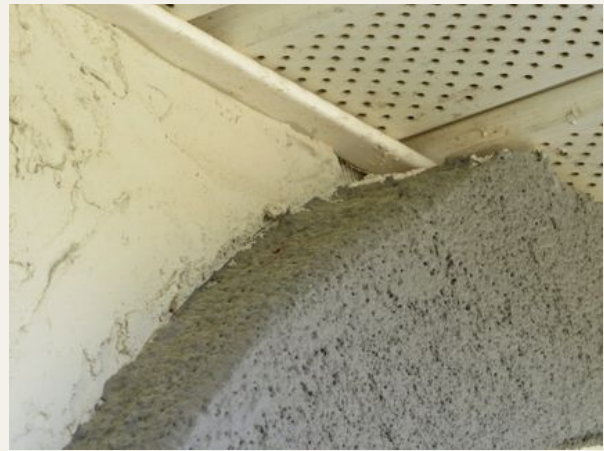
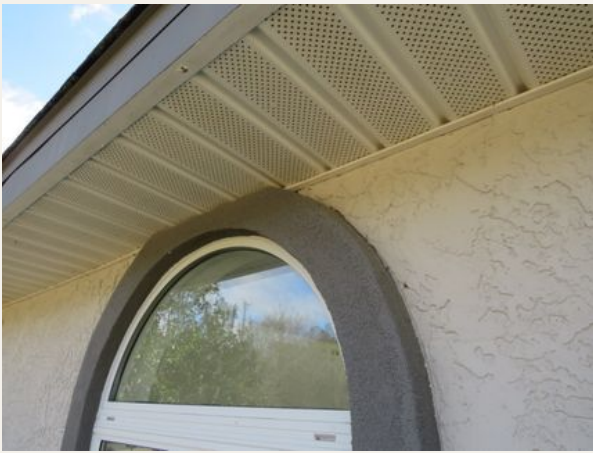
✂ **E1-7 EXTERIOR/GROUNDS:** Where the arched stucco trim above the windows meet the soffit, I observed gaps between the stucco coating and the interior envelope where the mesh underlayment was visible. I recommend these be sealed with an exterior rated sealant to prevent moisture intrusion in weather conditions with driving rain. No signs of previous or active leaks were observed.

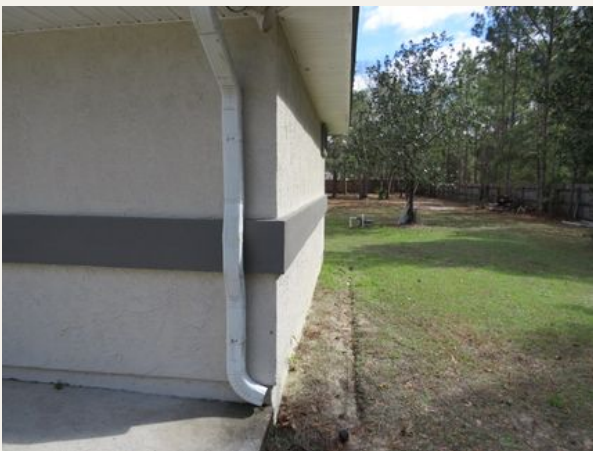
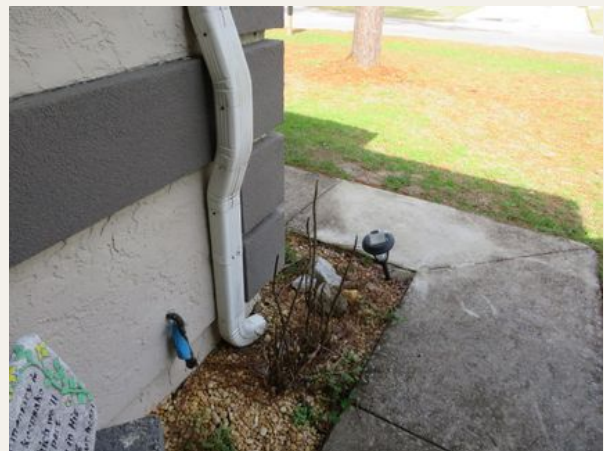
**R-2 ROOF/ATTIC:** There are two short sections of gutters with downspouts on the residence- one at the front of the residence over the walkway and one at the rear of the residence. Both downspouts terminate at the foundation, which can cause foundation settlement or moisture intrusion into the nearby structure, especially if there is any ponding. I recommend the downspouts be extended or routed to terminate at least 6 feet from the foundation.

I also recommend that gutters be cleaned of any debris that was observed to keep gutters from overflowing.

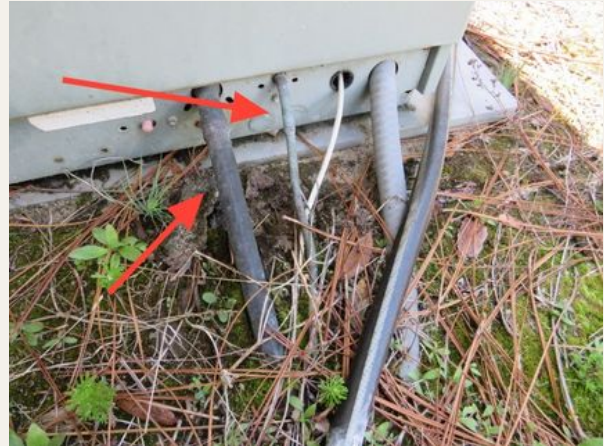
**HS-4 HEATING/COOLING SYSTEMS:** Insulation on the air-conditioning suction (large,

insulated) line was damaged or missing at areas and should be replaced. Repair may be performed by a qualified person.

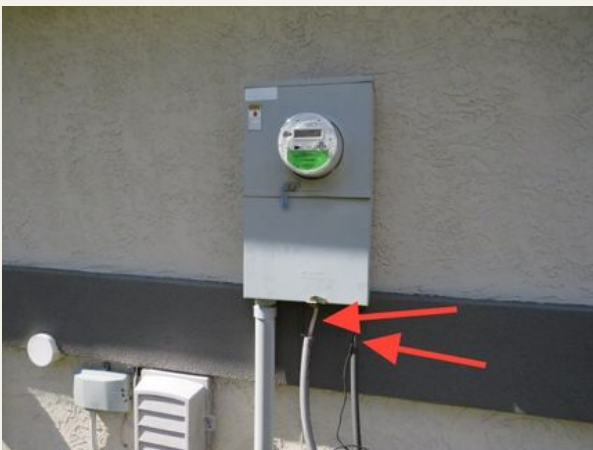
**E-1 ELECTRICAL:** The conduit for conductors at the panel are broken where it meets the panel. This has exposed the conductors and could be a safety hazard. Hire a licensed electrician to further evaluate and repair.

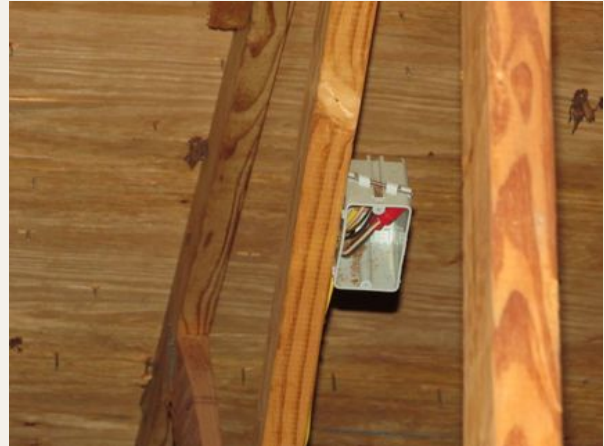
E-8 ELECTRICAL: In the attic, a junction box was observed without a cover plate. I recommend a qualified and licensed contractor install a protective cover.

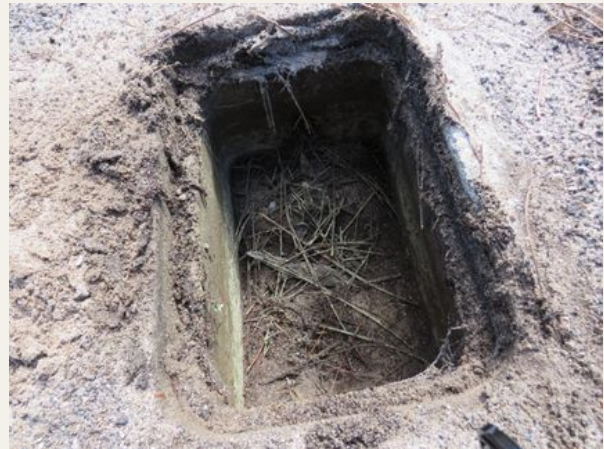
P-1 PLUMBING: Water main valve and supply line are covered in sand at meter box. I recommend the components in the meter box be visible to be able to quickly shut off the water at the box in the event of an emergency, or to monitor the meter for leaks.

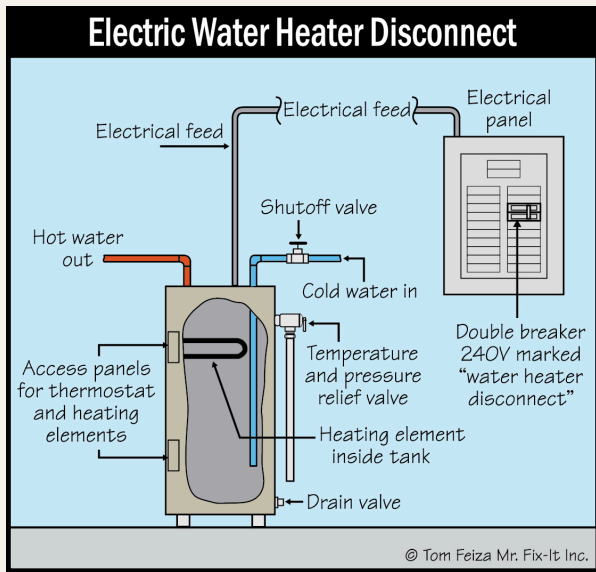
P-3 PLUMBING: All water heaters require a disconnect within sight or have provisions to install a lock on the switch or circuit breaker. If the panel with the branch circuit is not within sight, then a disconnect should be installed by a Licensed Electrical contractor.

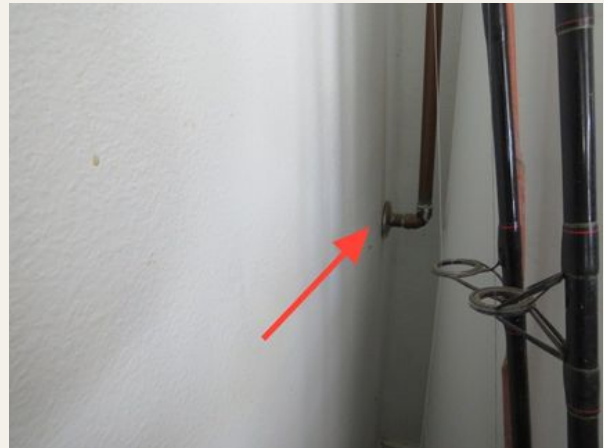
✂ P-4 PLUMBING: The discharge tube for the water heater temperature and pressure relief valve terminates to a location that cannot be monitored. This should be re-located so this termination can be monitored as a leak or discharge should be identified and corrected as soon as possible to ensure this important safety device is performing as intended.

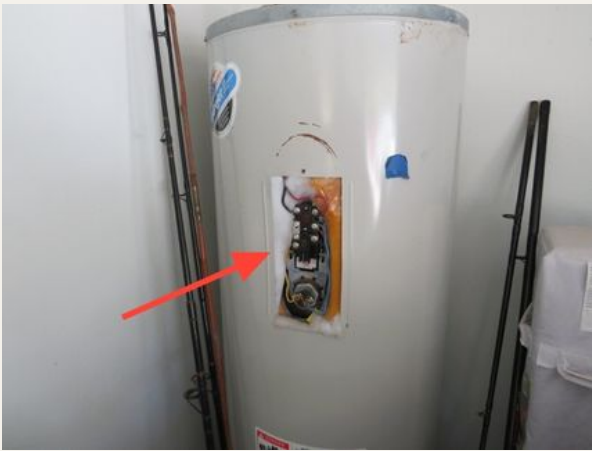
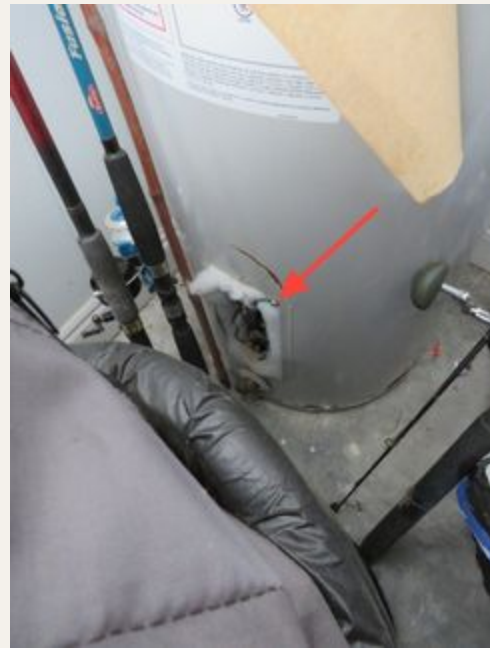
✂ P-5 PLUMBING: Missing covers for electrical components

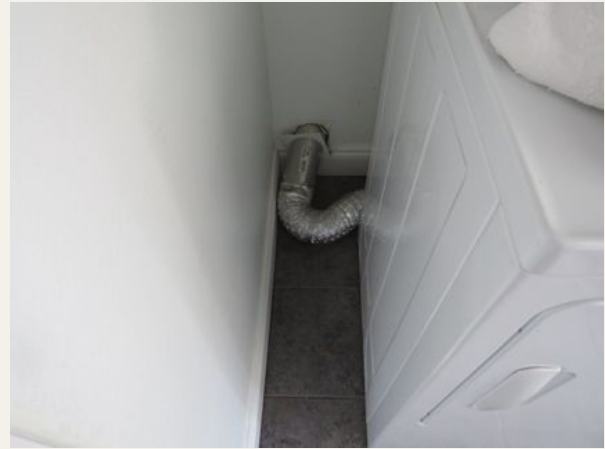
✂ **P-11 PLUMBING:** The dryer duct on this unit appears to be oversized and is restricted. I recommend reducing the length of the flexible duct and reducing the number of bends in it as much as possible.

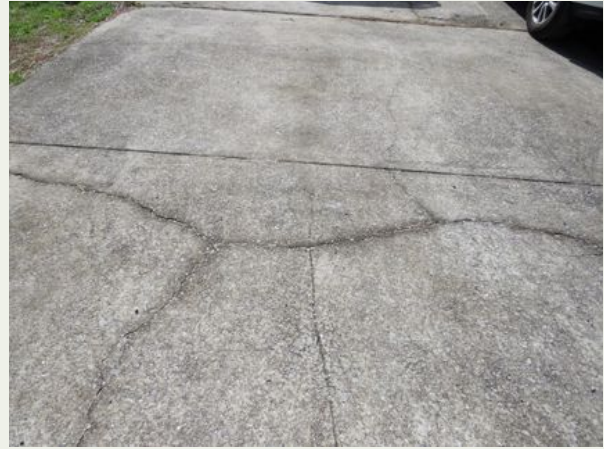
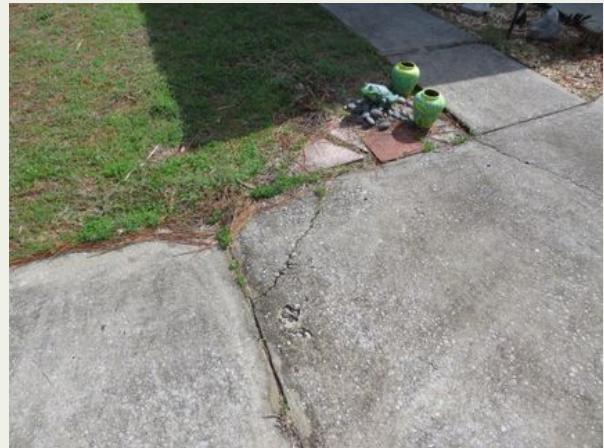
🔧 **(E1-1) Recommended Maintenance:** Typical cracks were noted in the driveway flatwork. No immediate repair appears necessary, though water will continue to deteriorate the surface until the driveway is repaired. I recommend sealing these cracks to prevent further water intrusion.

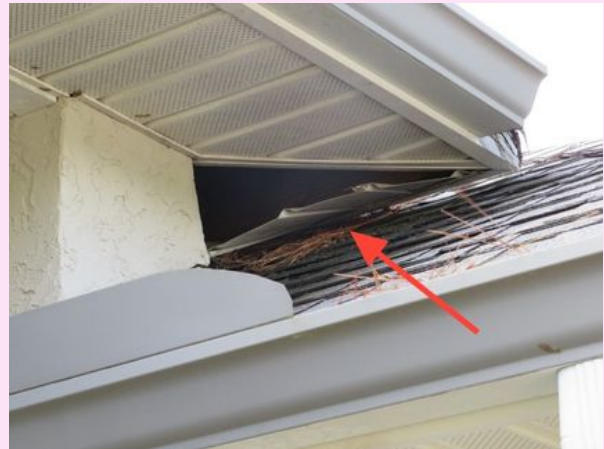
(E1-4) Defect In Need of Correction: Vented soffit in the area of the front entrance is pulling from the fascia and sagging down. This is creating a large opening in the buildings envelope where moisture, animals, or other pests may enter the attic space. I recommend the soffit be repaired by a qualified and licensed contractor.

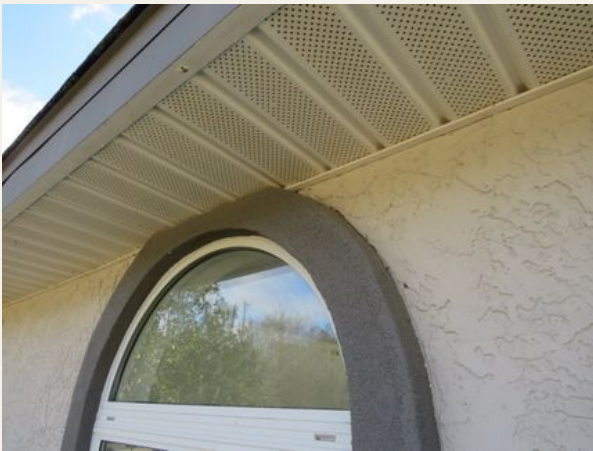
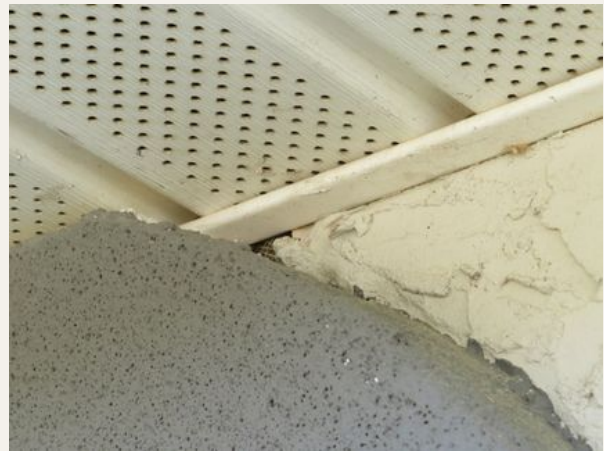
🛠️ **(E1-7) Recommended Repair:** Where the arched stucco trim above the windows meet the soffit, I observed gaps between the stucco coating and the interior envelope where the mesh underlayment was visible. I recommend these be sealed with an exterior rated sealant to prevent moisture intrusion in weather conditions with driving rain. No signs of previous or active leaks were observed.

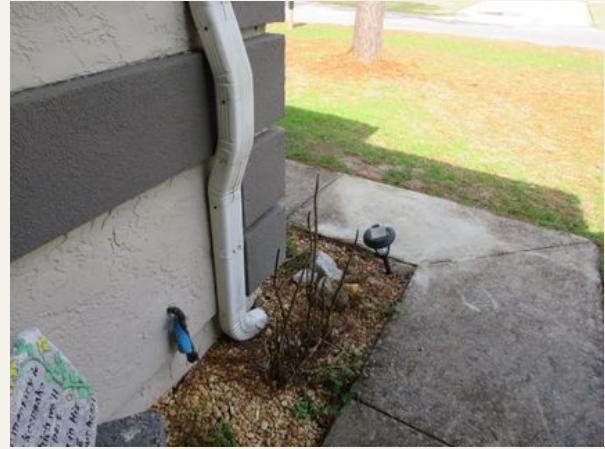
🔧 **(R-2) Recommended Repair:** There are two short sections of gutters with downspouts on the residence- one at the front of the residence over the walkway and one at the rear of the residence. Both downspouts terminate at the foundation, which can cause foundation settlement or moisture intrusion into the nearby structure, especially if there is any ponding. I recommend the downspouts be extended or routed to terminate at least 6 feet from the foundation.

I also recommend that gutters be cleaned of any debris that was observed to keep gutters from overflowing.

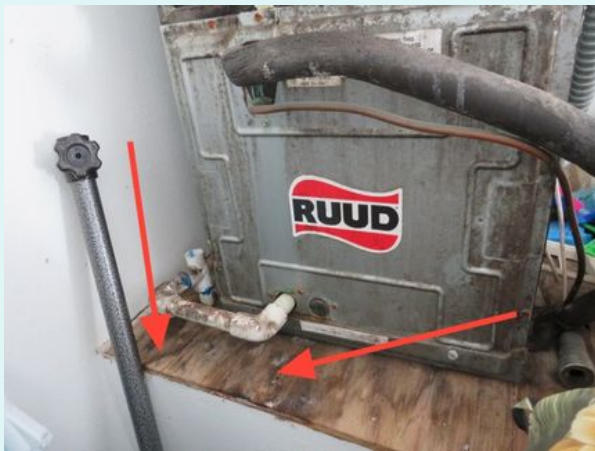
An active condensate leak was noted at the furnace. This should be repaired as soon as possible to prevent on-going damage to the building materials. Hire a licensed heating contractor to further evaluate and repair all condensate leaks and repair damaged finishes as needed.

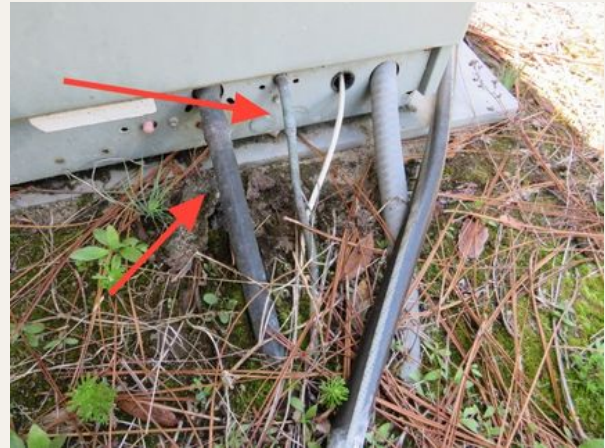
✂️ (HS-4) **Recommended Repair:** Insulation on the air-conditioning suction (large, insulated) line was damaged or missing at areas and should be replaced. Repair may be performed by a qualified person.

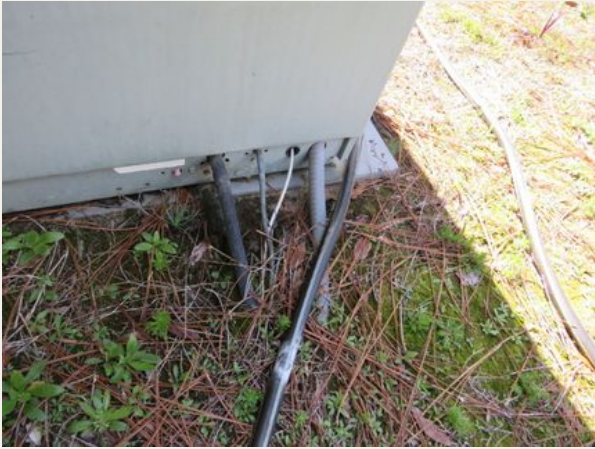
✂️ (HS-7) **Recommended Repair:** Refrigerant lines and electrical conductors/conduit to the unit are partially underground. Where they come out of the ground to enter the compressor, they are exposed at grade. I recommend these be protected, as vehicles or lawn mowers could damage them on accident, causing an expensive repair.

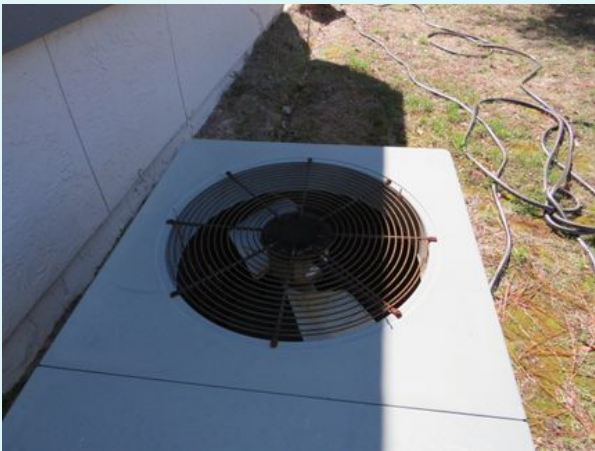
Corroded fins were noted on the outdoor air conditioner compressor unit. This can inhibit proper operation of this system. I recommend having this further evaluated and repaired by a heating and cooling contractor. The damaged fins can impact performance and efficiency, but they may be hard to repair.

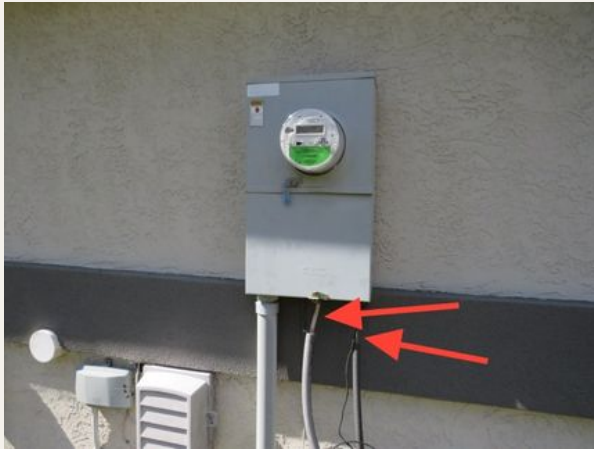
🔧 **(E-1) Recommended Repair:** The conduit for conductors at the panel are broken where it meets the panel. This has exposed the conductors and could be a safety hazard. Hire a licensed electrician to further evaluate and repair.

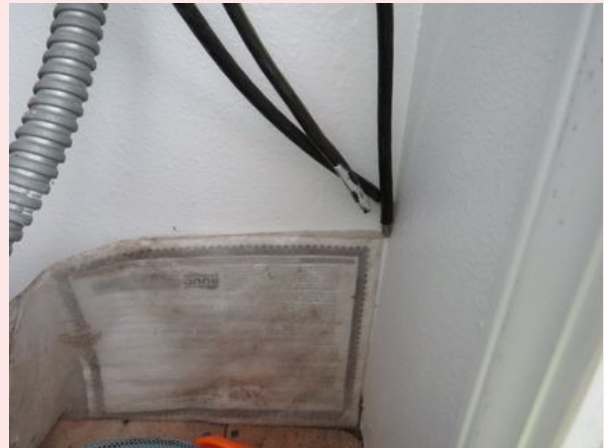
(E-7) Major Defect: Exposed wiring was observed coming from the attic space into the area near the garage central HVAC unit. These wires appear to be large gauge aluminum wires. While a voltage detector utilized by the inspector indicated these conductors are not "hot", they are not appropriately capped and terminated. I recommend a qualified electrical contractor assess and repair appropriately, as this could be a safety concern to the house and its occupants.

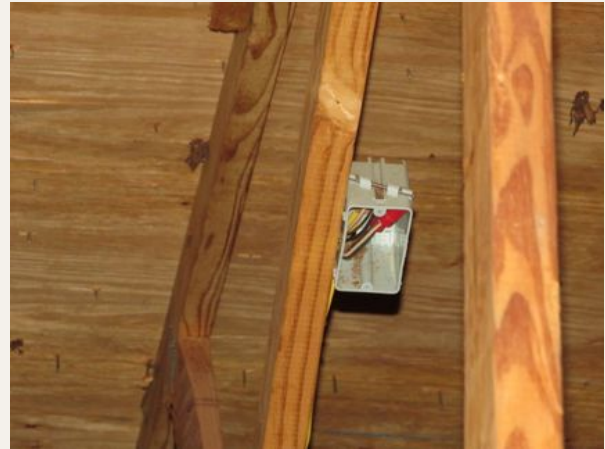
✂️ **(E-8) Recommended Repair:** In the attic, a junction box was observed without a cover plate. I recommend a qualified and licensed contractor install a protective cover.

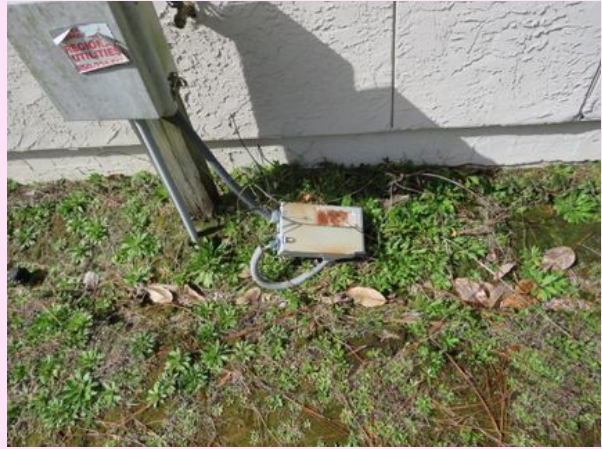
(E-9) Defect In Need of Correction: The service disconnect for the grinder pump was observed laying on the ground. I recommended a qualified electrical contractor mount this service disconnect box appropriately and assess the box for any water damage or signs of electrical shorts.

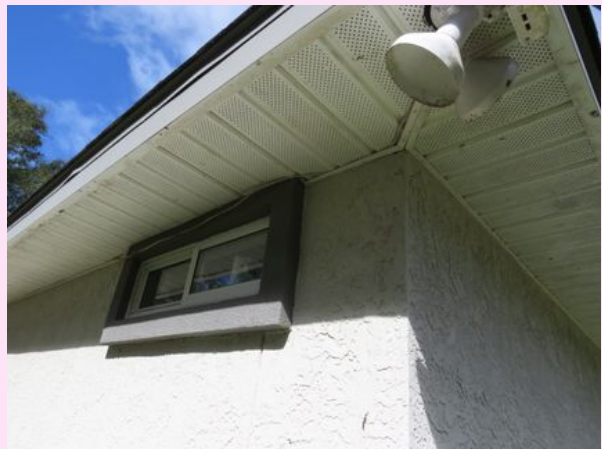
(E-10) Defect In Need of Correction: Unprotected wiring was observed on the rear exterior floodlights. I recommend a licensed electrical contractor assess and repair.

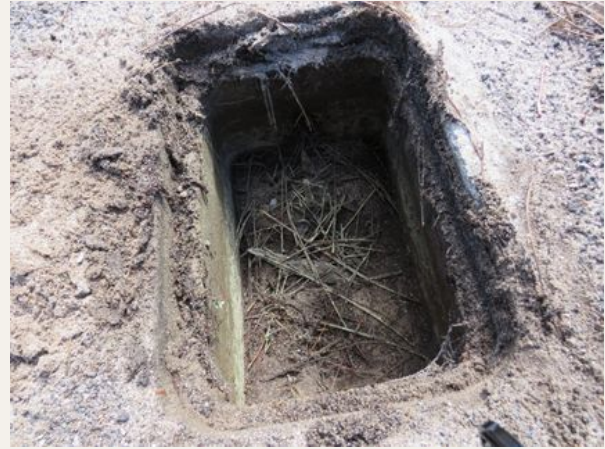
🔧 **(P-1) Recommended Repair:** Water main valve and supply line are covered in sand at meter box. I recommend the components in the meter box be visible to be able to quickly shut off the water at the box in the event of an emergency, or to monitor the meter for leaks.

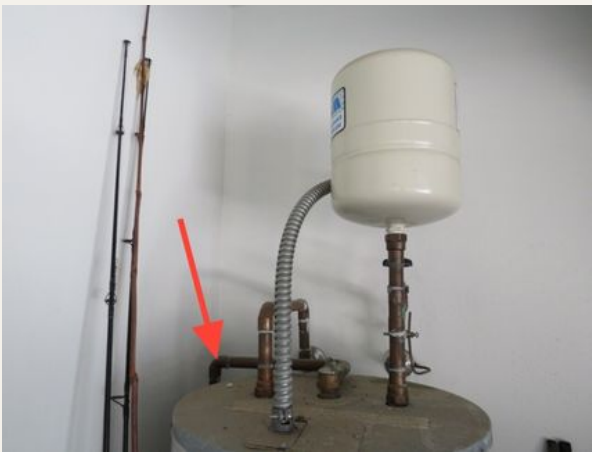
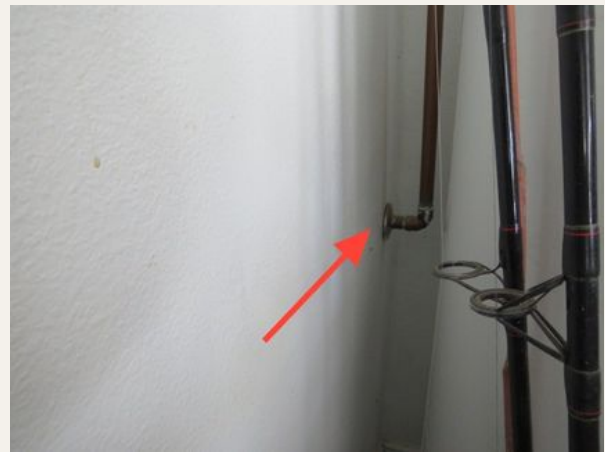
🔧 (P-4) Recommended Repair: The discharge tube for the water heater temperature and pressure relief valve terminates to a location that cannot be monitored. This should be relocated so this termination can be monitored as a leak or discharge should be identified and corrected as soon as possible to ensure this important safety device is performing as intended.

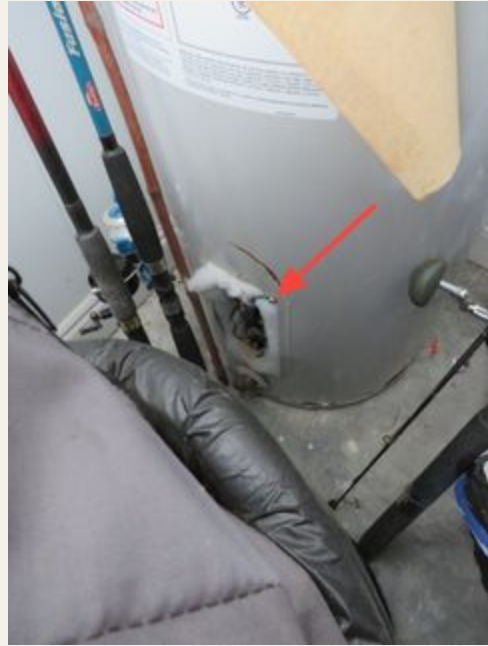
🔧 (P-5) Recommended Repair: Missing covers for electrical components

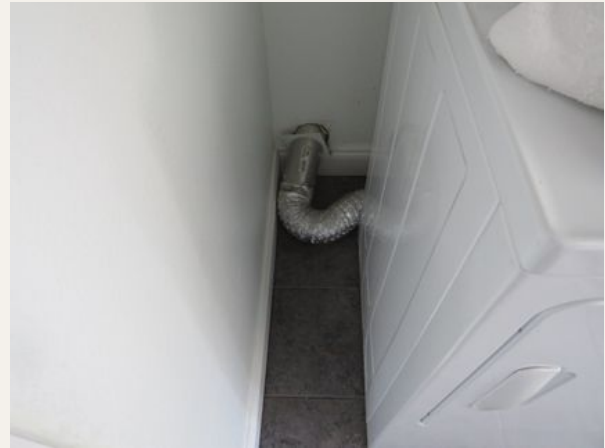
✂️ (P-11) **Recommended Repair:** The dryer duct on this unit appears to be oversized and is restricted. I recommend reducing the length of the flexible duct and reducing the number of bends in it as much as possible.
