Inspection report for the property at

1234 Fake Street

This report is prepared exclusively for **John Doe**
Inspected On: **2023-02-10**

Sighthound Home Inspections, LLC
850-296-8329

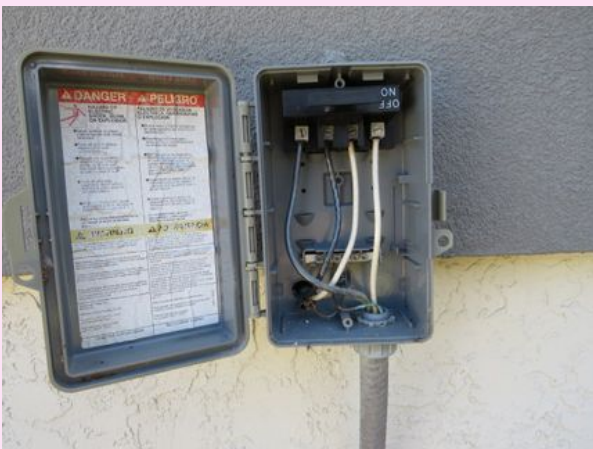
E-6 ELECTRICAL: The disconnect for the heat pump is not properly protected: openings were noted in this box due to the cover plate is missing. I recommend repair by a licensed and qualified contractor.

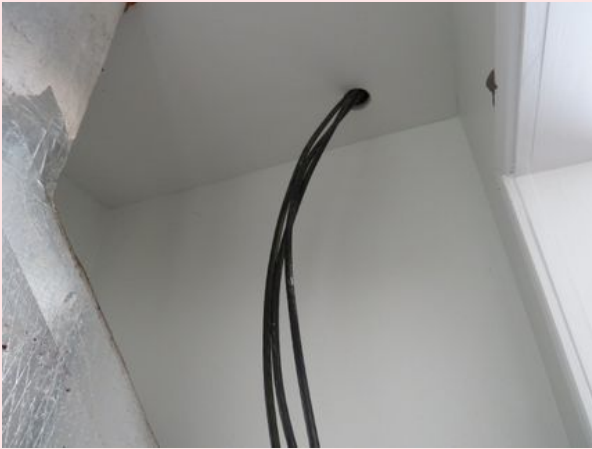
E-7 ELECTRICAL: Exposed wiring was observed coming from the attic space into the area near the garage central HVAC unit. These wires appear to be large gauge aluminum wires. While a voltage detector utilized by the inspector indicated these conductors are not "hot", they are not appropriately capped and terminated. I recommend a qualified electrical contractor assess and repair appropriately, as this could be a safety concern to the house and its occupants.

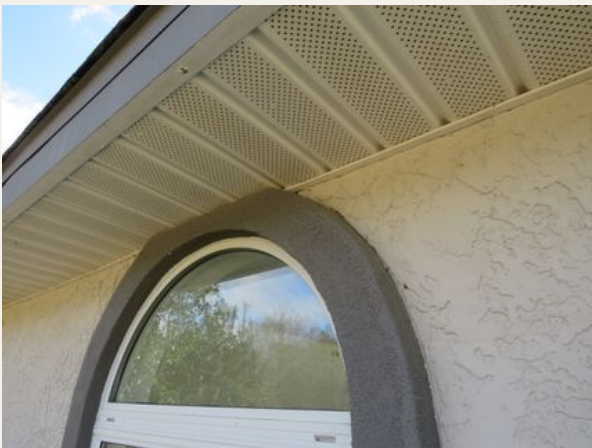
✂ **E1-7 EXTERIOR/GROUNDS:** Where the arched stucco trim above the windows meet the soffit, I observed gaps between the stucco coating and the interior envelope where the mesh underlayment was visible. I recommend these be sealed with an exterior rated sealant to prevent moisture intrusion in weather conditions with driving rain. No signs of previous or active leaks were observed.

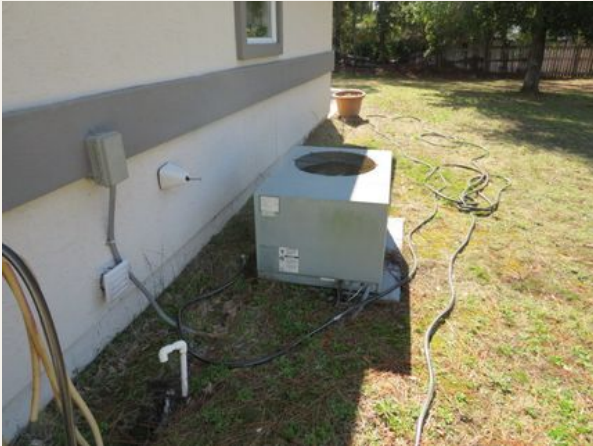
**HS-4 HEATING/COOLING SYSTEMS:** Insulation on the air-conditioning suction (large,

insulated) line was damaged or missing at areas and should be replaced. Repair may be performed by a qualified person.

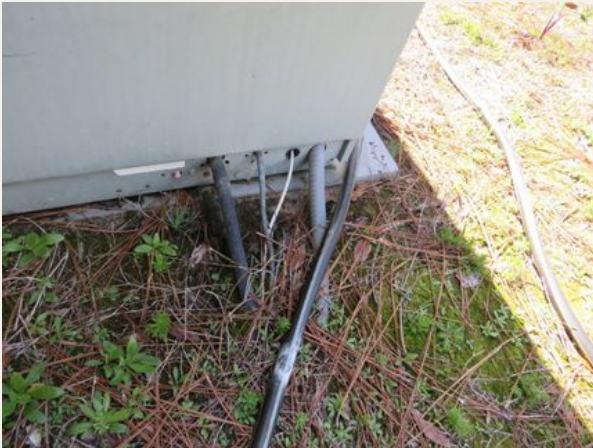
**HS-7 HEATING/COOLING SYSTEMS:** Refrigerant lines and electrical conductors/conduit to the unit are partially underground. Where they come out of the ground to enter the compressor, they are exposed at grade. I recommend these be protected, as vehicles or lawn mowers could damage them on accident, causing an expensive repair.

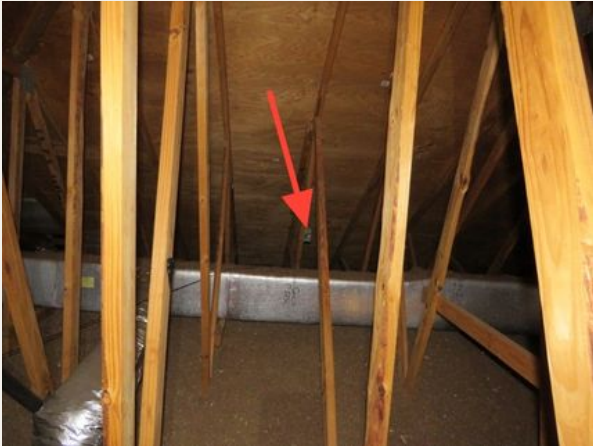
E-8 ELECTRICAL: In the attic, a junction box was observed without a cover plate. I recommend a qualified and licensed contractor install a protective cover.

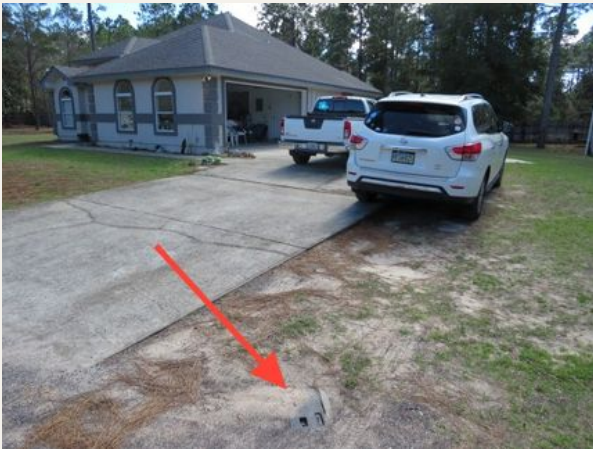
P-1 PLUMBING: Water main valve and supply line are covered in sand at meter box. I recommend the components in the meter box be visible to be able to quickly shut off the water at the box in the event of an emergency, or to monitor the meter for leaks.

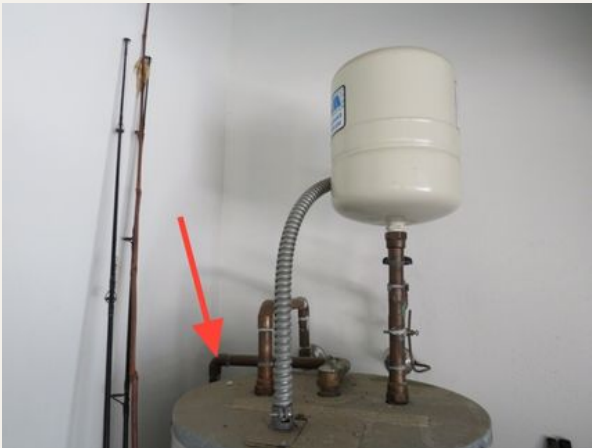
✂ P-4 PLUMBING: The discharge tube for the water heater temperature and pressure relief valve terminates to a location that cannot be monitored. This should be re-located so this termination can be monitored as a leak or discharge should be identified and corrected as soon as possible to ensure this important safety device is performing as intended.

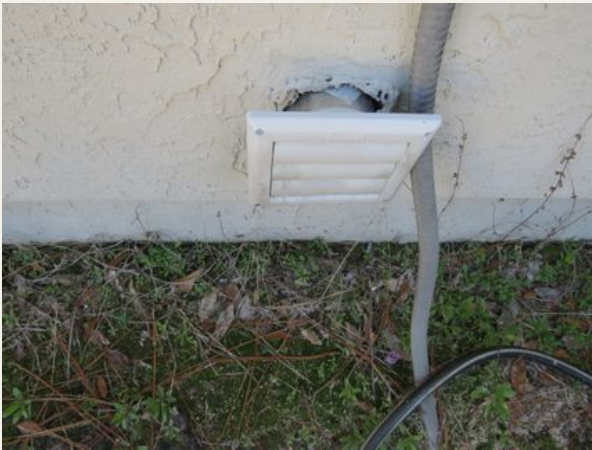
✂ **P-10 PLUMBING:** The dryer exhaust duct termination at the exterior of the building is not properly secured to the exterior wall. Make sure that the hood is mounted properly for safe and trouble-free operations. Repair may be performed by a qualified person.

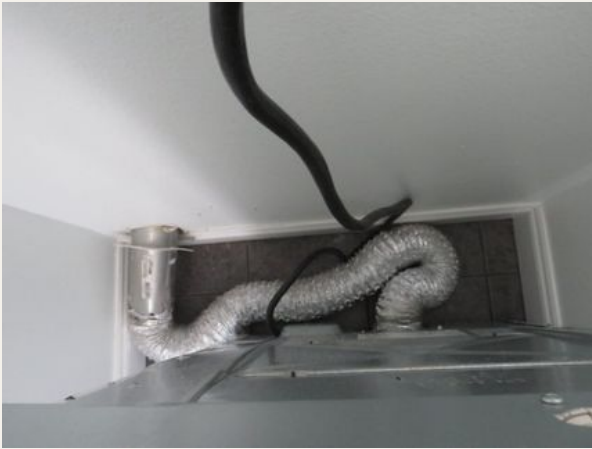
✂ **P-11 PLUMBING:** The dryer duct on this unit appears to be oversized and is restricted. I recommend reducing the length of the flexible duct and reducing the number of bends in it as much as possible.

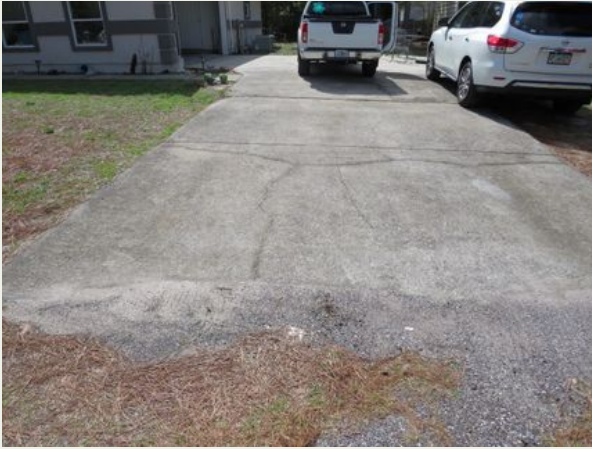
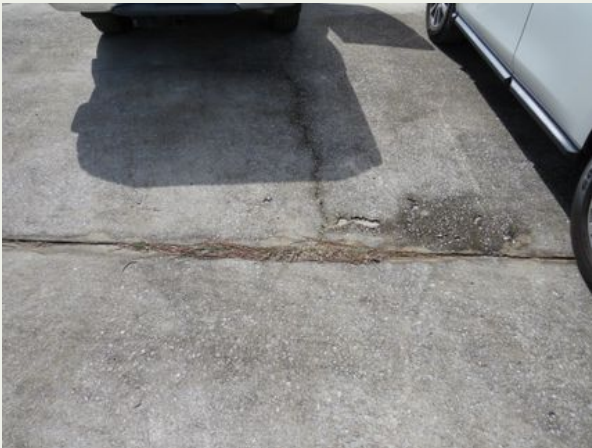
🔧 **(E1-1) Recommended Maintenance:** Typical cracks were noted in the driveway flatwork. No immediate repair appears necessary, though water will continue to deteriorate the surface until the driveway is repaired. I recommend sealing these cracks to prevent further water intrusion.

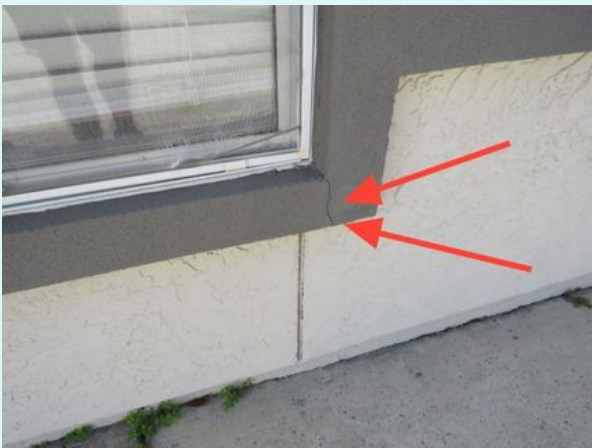
(E1-3) Additional Evaluation Recommended:

Exterior trim located at the rear exterior window at the patio was cracked which will require attention. Being a part of a stucco system, I recommend additional evaluation and repair by a qualified and licensed contractor.

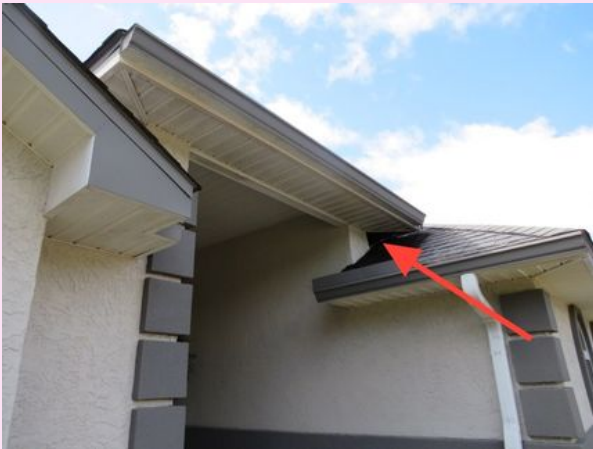
E1-4 EXTERIOR/GROUNDS: Vented soffit in the area of the front entrance is pulling from the fascia and sagging down. This is creating a large opening in the buildings envelope where moisture, animals, or other pests may enter the attic space. I recommend the soffit be repaired by a qualified and licensed contractor.

(E1-4) Defect In Need of Correction: Vented soffit in the area of the front entrance is pulling from the fascia and sagging down. This is creating a large opening in the buildings envelope where moisture, animals, or other pests may enter the attic space. I recommend the soffit be repaired by a qualified and licensed contractor.

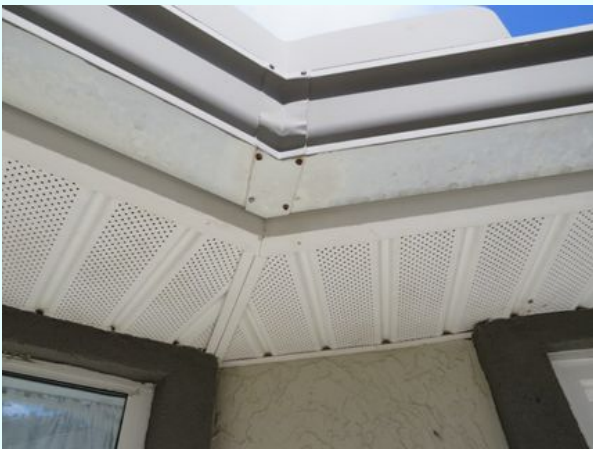
🕒 **(E1-5) Monitor:** Around the perimeter of the residence I observed fascia and gutter fasteners that are corroded. While not an immediate concern, I recommend monitoring these areas for any signs of failure at these fastening points.

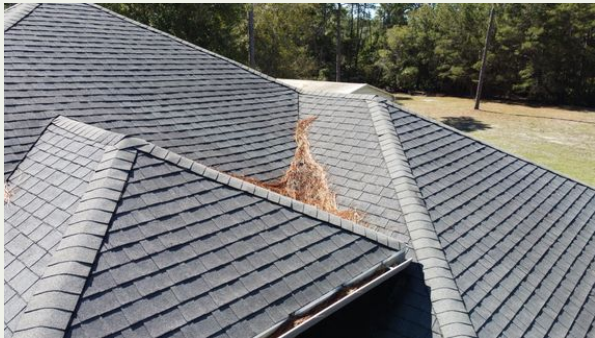
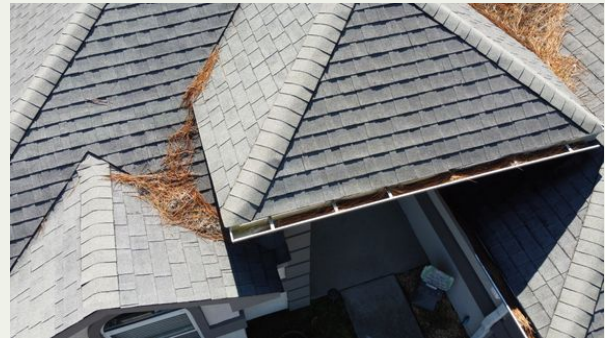
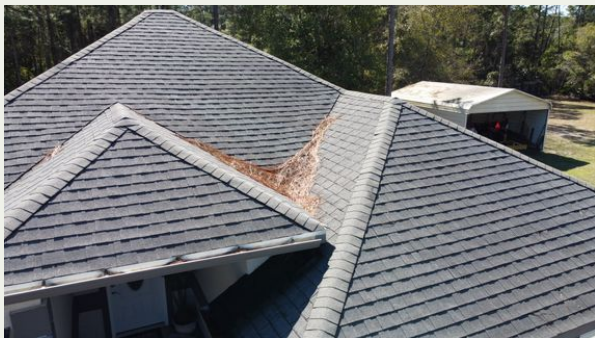
🔧 **(R-1) Recommended Maintenance:** Many of the roof valleys observed have a buildup of debris from surrounding trees. I recommend these valleys be cleared of any debris on a routine basis. A buildup of this debris can cause moisture to remain in this area, which could cause moisture intrusion into the home or reduce the service life of the roof covering material.

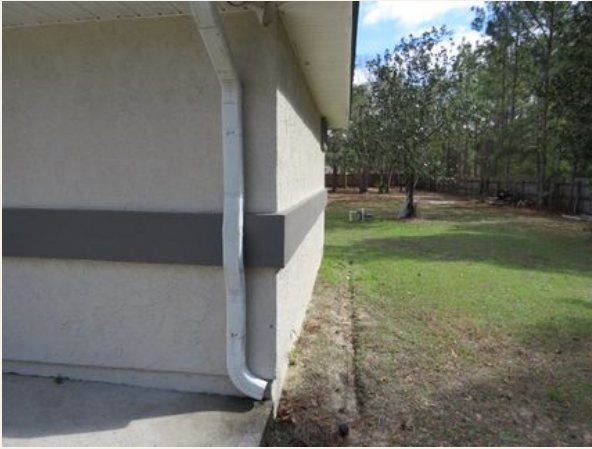
🔧 **(R-2) Recommended Repair:** There are two short sections of gutters with downspouts on the residence- one at the front of the residence over the walkway and one at the rear of the residence. Both downspouts terminate at the foundation, which can cause foundation settlement or moisture intrusion into the nearby structure, especially if there is any ponding. I recommend the downspouts be extended or routed to terminate at least 6 feet from the foundation.

I also recommend that gutters be cleaned of any debris that was observed to keep gutters from overflowing.

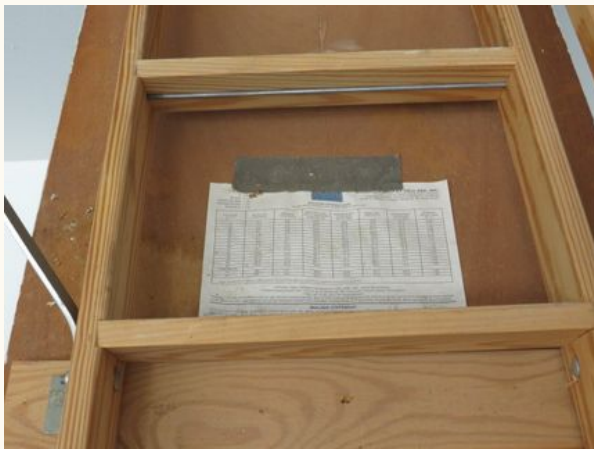
✦ **(R-5) Note:** Garage attic access ladder has a chart from the company who installed the insulation regarding the square footage, average R-Value, and number of bags blown in.

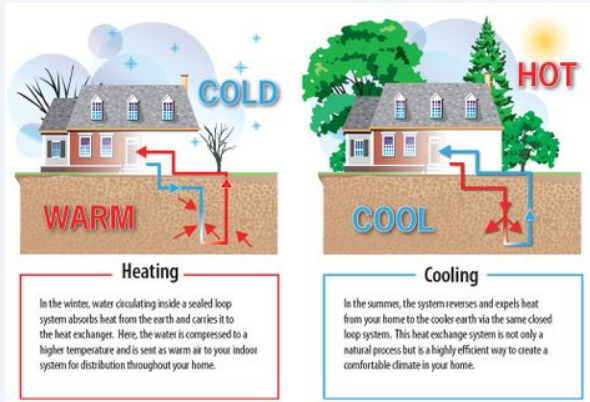
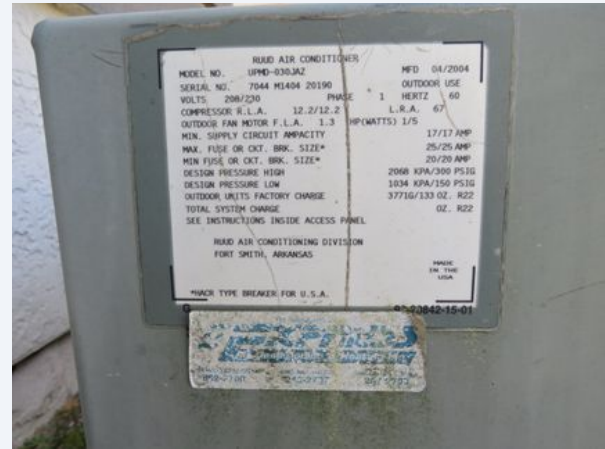
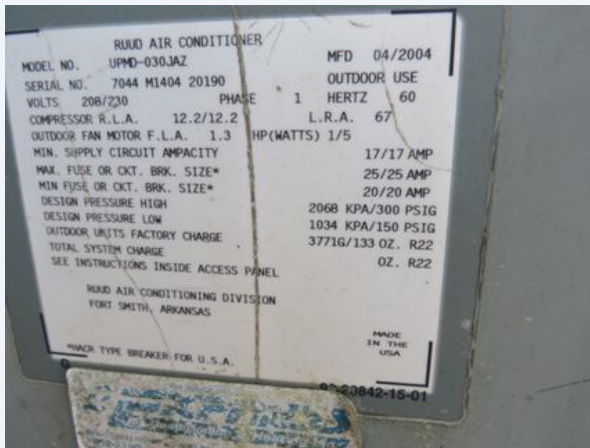
A/C OBSERVATIONS : ♦ REFRIGERANT LINES (Missing Insulation At Condenser, Missing Insulation At "Inclusive"), ♦ CLEARANCES (Exterior Vents--Dryer, Furnace or WH), ♦ EXTERIOR -CABINET (Damaged Fins), ♦ AGE (Heat Pump--Working Old)

⚡ (HS-3) Note: This units data plate shows it was manufactured in 2004.

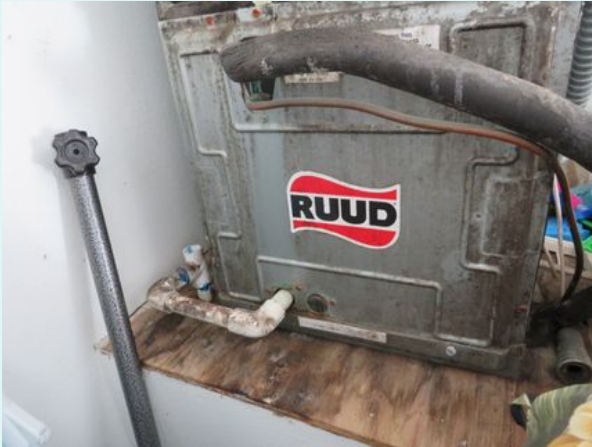
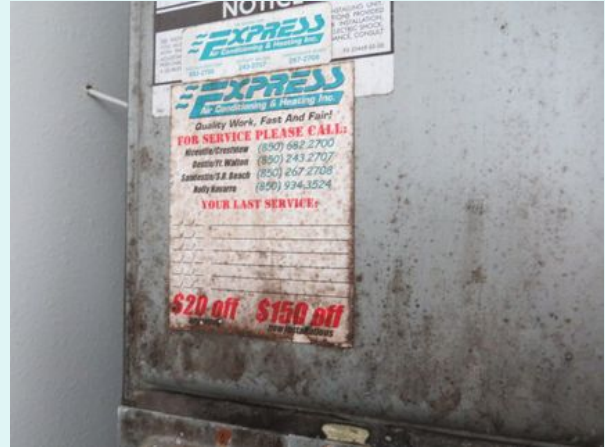
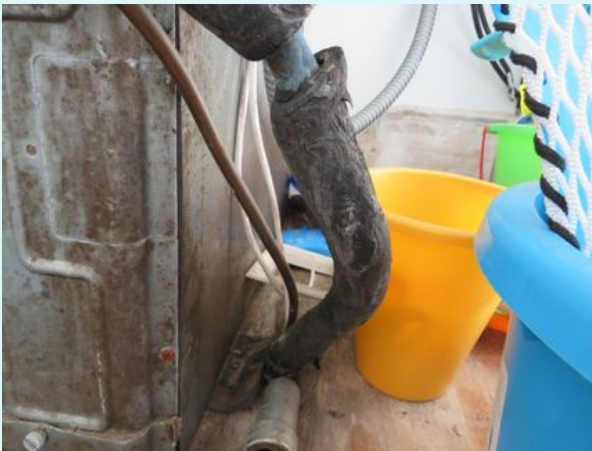
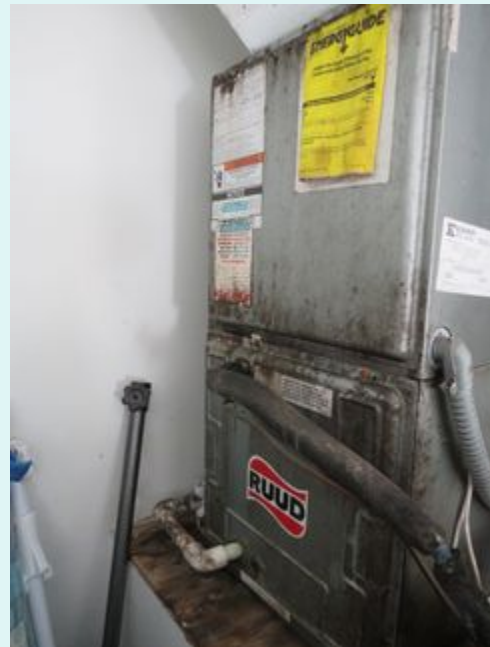
The central heating/cooling unit was located in the garage. Due to the age of the unit, it being located in an unconditioned space, and additional factors, there appears to be moisture related issues including signs of condensate leaks, partially insulated/corroded refrigerant lines, and what appears to be a dark organic growth on the outside of the unit. I recommend a licensed HVAC contractor evaluate the unit further.

Due to personal items blocking immediate access to the unit, no further examination could be completed.

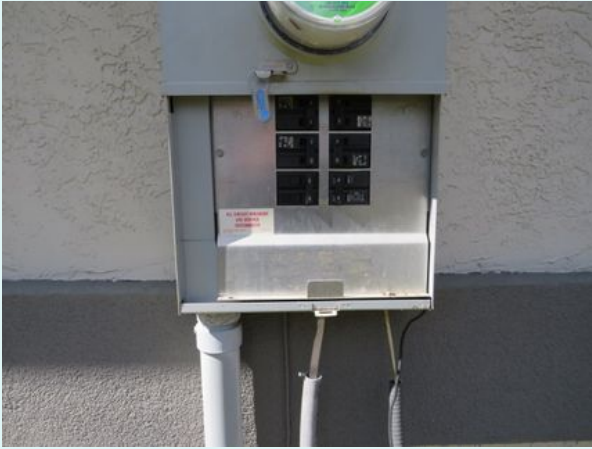
🔧 **(E-1) Recommended Repair:** The conduit for conductors at the panel are broken where it meets the panel. This has exposed the conductors and could be a safety hazard. Hire a licensed electrician to further evaluate and repair.

The service panel directory is missing or incomplete. All service panels should have a complete Breaker / Fuse Directory. A directory will allow a specific circuit to be disconnected without shutting off the homes main disconnect. The inspector has no way of confirming the accuracy of the directory, only whether it is missing or appears incomplete. For personal safety a complete circuit directory is required. A licensed electrician should be contacted about developing a panel directory.

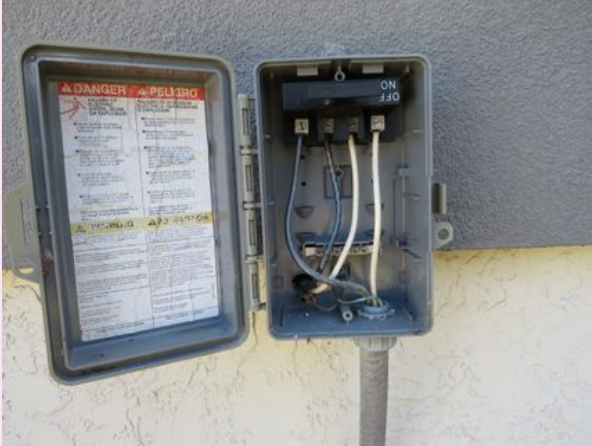
(E-6) Defect In Need of Correction: The disconnect for the heat pump is not properly protected: openings were noted in this box due to the cover plate is missing. I recommend repair by a licensed and qualified contractor.

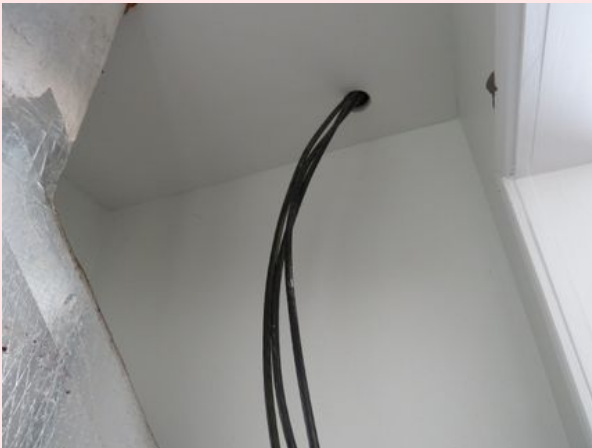
(E-7) Major Defect: Exposed wiring was observed coming from the attic space into the area near the garage central HVAC unit. These wires appear to be large gauge aluminum wires. While a voltage detector utilized by the inspector indicated these conductors are not "hot", they are not appropriately capped and terminated. I recommend a qualified electrical contractor assess and repair appropriately, as this could be a safety concern to the house and its occupants.

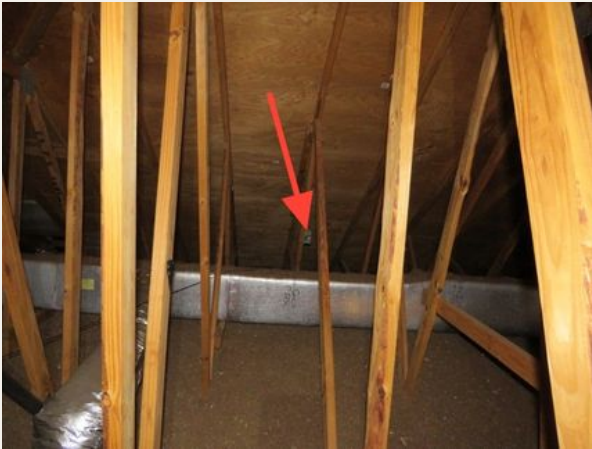
✂️ **(E-8) Recommended Repair:** In the attic, a junction box was observed without a cover plate. I recommend a qualified and licensed contractor install a protective cover.

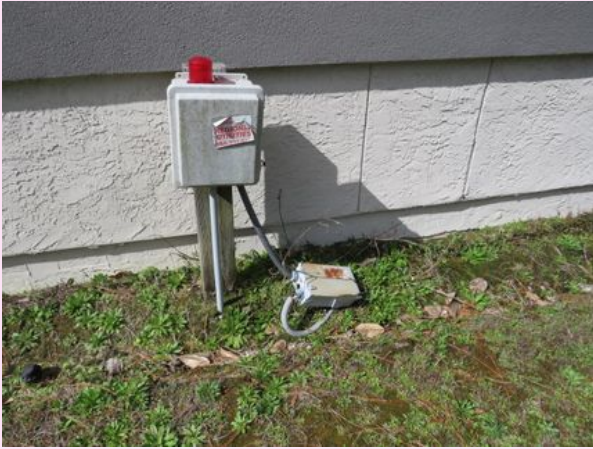
(E-9) Defect In Need of Correction: The service disconnect for the grinder pump was observed laying on the ground. I recommended a qualified electrical contractor mount this service disconnect box appropriately and assess the box for any water damage or signs of electrical shorts.

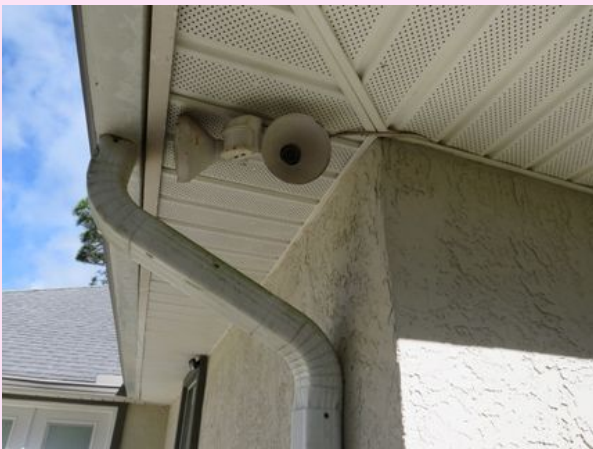
(E-10) Defect In Need of Correction: Unprotected wiring was observed on the rear exterior floodlights. I recommend a licensed electrical contractor assess and repair.

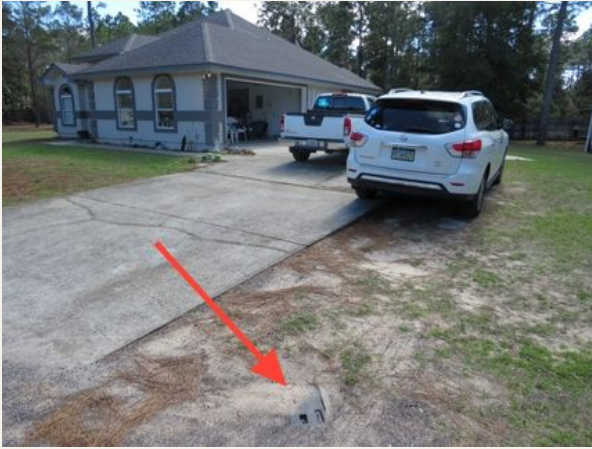
🔧 **(P-1) Recommended Repair:** Water main valve and supply line are covered in sand at meter box. I recommend the components in the meter box be visible to be able to quickly shut off the water at the box in the event of an emergency, or to monitor the meter for leaks.

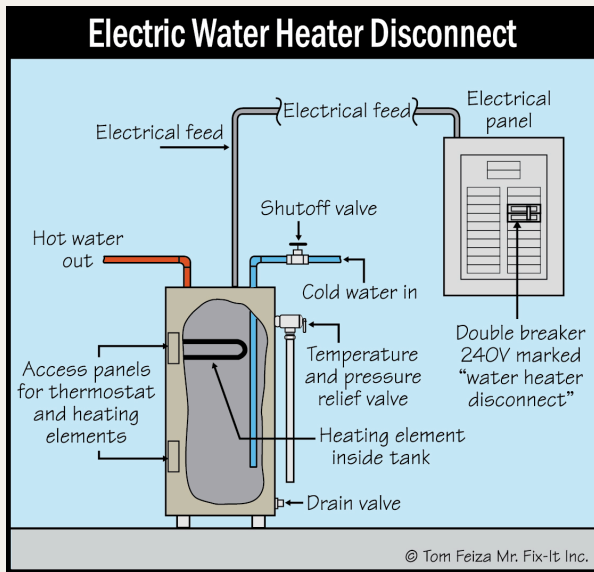
✂ **(P-3) Recommended Repair:** All **water heaters require** a **disconnect** within sight or **have** provisions to install a lock on **the** switch or circuit breaker. If the panel with **the** branch circuit **is** not within sight, then a disconnect should be installed by a Licensed

Electrical contractor.

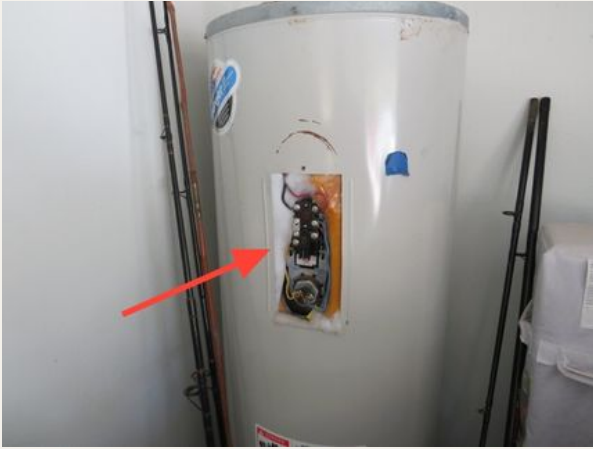
🔧 (P-5) Recommended Repair: Missing covers for electrical components

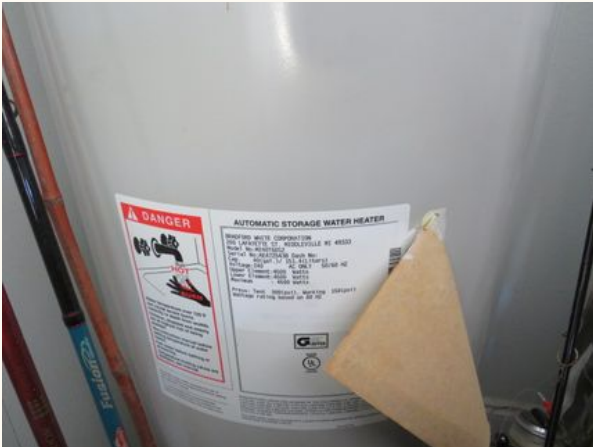
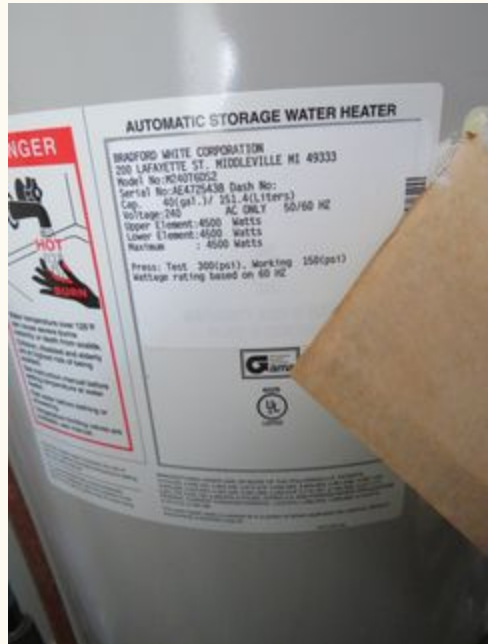
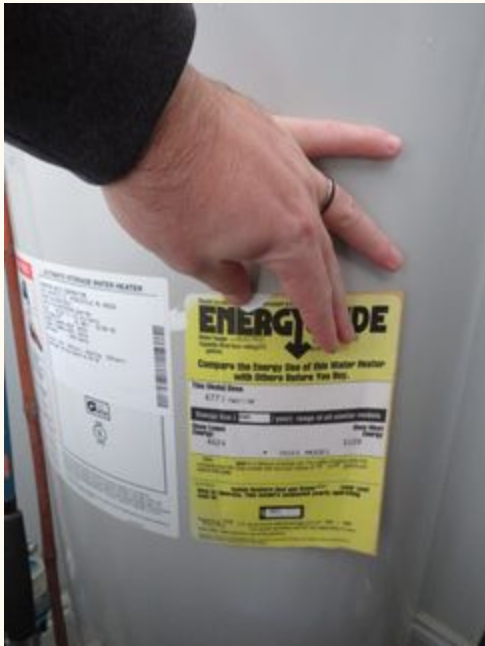
✦ **(P-6) Note:** Water heater data plate indicates the capacity at 40 gallons. A lookup of the serial number indicates the unit was manufactured in May of 2004.

(P-7) Due Diligence: This hot water heater appears to be approximately 19 years old. The average life expectancy for a hot water heater is approximately 6 to 12 years. While no deficiencies were observed in the hot water production of this unit, I recommend monitoring this water heater, as it could be approaching the end of its service life.

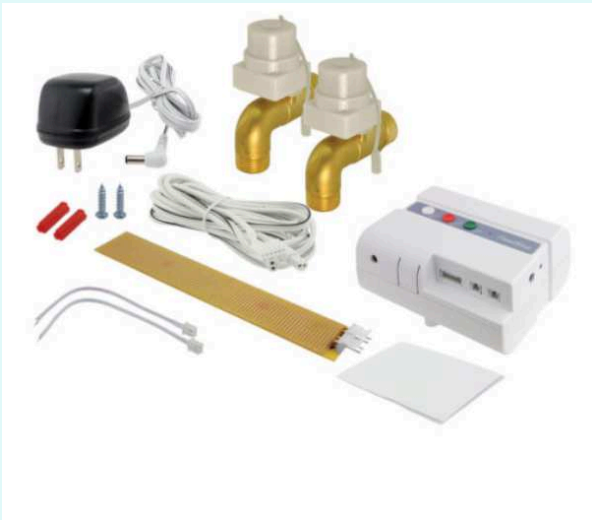
**(P-9) Improve / Upgrade / Safety:** A moisture alarm with water shut-off features is recommended under the washing machine to protect against accidental leaks in the supply hoses. Pans can be effective when there is a drain, but even these will not protect against a burst supply connector. A moisture alarm with automatic shut-off will. Watts is a brand I have seen installed: [Link](#).

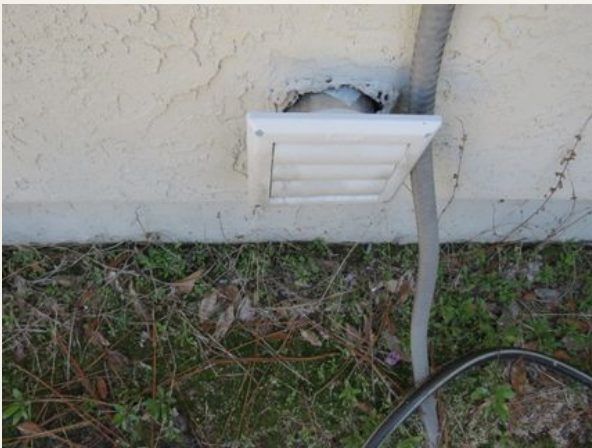
**(P-10) Recommended Repair:** The dryer exhaust duct termination at the exterior of the building is not properly secured to the exterior wall. Make sure that the hood is mounted properly for safe and trouble-free operations. Repair may be performed by a qualified person.

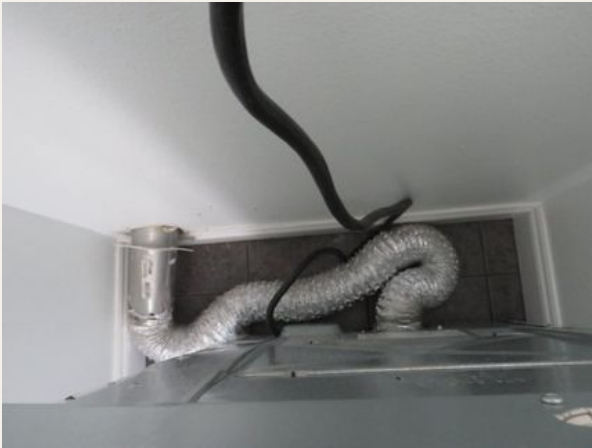
✂️ (P-11) **Recommended Repair:** The dryer duct on this unit appears to be oversized and is restricted. I recommend reducing the length of the flexible duct and reducing the number of bends in it as much as possible.

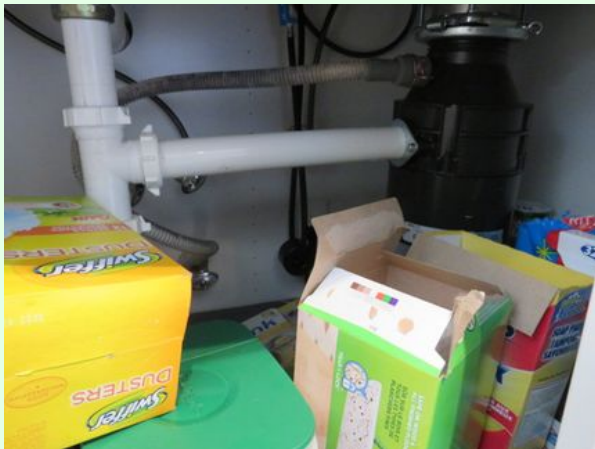
(K-2) Functional: Sink and faucet appeared functional with no active leaks.
